ASD-TR-61-713  
Part II

RESEARCH ON THE BASIC NATURE OF  
STRESS CORROSION FOR VARIOUS STRUCTURAL ALLOYS AT  
ROOM AND ELEVATED TEMPERATURES

TECHNICAL DOCUMENTARY REPORT NO. ASD-TR-61-713, PT. II  
February 1963

Directorate of Materials and Processes  
Aeronautical Systems Division  
Air Force Systems Command  
Wright-Patterson Air Force Base, Ohio

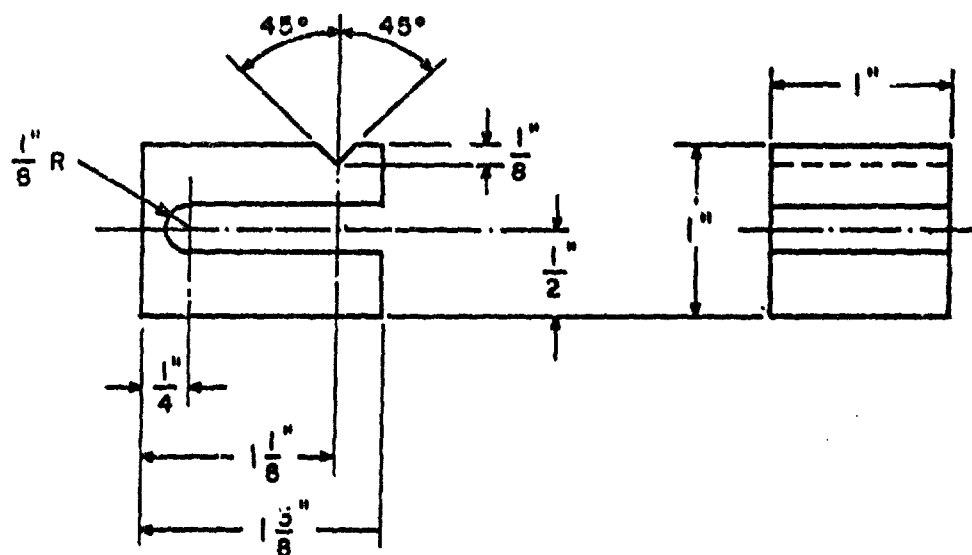
FIG. 2 - STRESS CORROSION TEST SPECIMEN FOR EVALUATION OF SUSCEPTIBILITY IN THE SHORT-TRANSVERSE DIRECTION OF PLATE.

Since testing of 1-inch thick plate in the short-transverse direction was the concern of this work, a specimen geometry as shown in Fig. 2 was designed. A set of 24 lever-arm loading stress-corrosion units was constructed for making the tests. Several of the units illustrating the manner of loading are shown in Fig. 3. In order to obtain more uniform distribution of load over the test specimen, two Ti-6Al-4V titanium alloy pins at right angles were placed between the specimen and the loading ram. A 0.192-inch diameter pin was placed in the groove in the top of the specimen, and a second pin having a radius of curvature of 0.10 inch in the longitudinal profile and 0.190 inch minimum diameter was placed at right angles to the first. Thin rubber sheet served to insulate the lower pin from the specimen, and the stainless steel loading ram was coated with Stop-Off strippable lacquer. Corrosion test media employed were the following basic solutions: (1) 57 g NaCl, 10 ml 30% H<sub>2</sub>O<sub>2</sub>, and water to make 1 liter, and (2) 3 g NaCl, 36 g CrO<sub>3</sub>, 30 g K<sub>2</sub>Cr<sub>2</sub>O<sub>7</sub> and water to make 1 liter. Initially an addition of 0.01 g Aerosol wetting agent was made to the solutions. However, when it was discovered that this addition apparently had an adverse effect on the stabilities of the solutions, and that there was a significant difference in behavior of 7075, depending on whether or not the solution contained the Aerosol addition or not, the Aerosol was left out. The specimens were immersed continuously, and the solutions were changed daily except Saturdays and Sundays. The load was fully applied to the test specimen before the corrosion medium was added to the container.

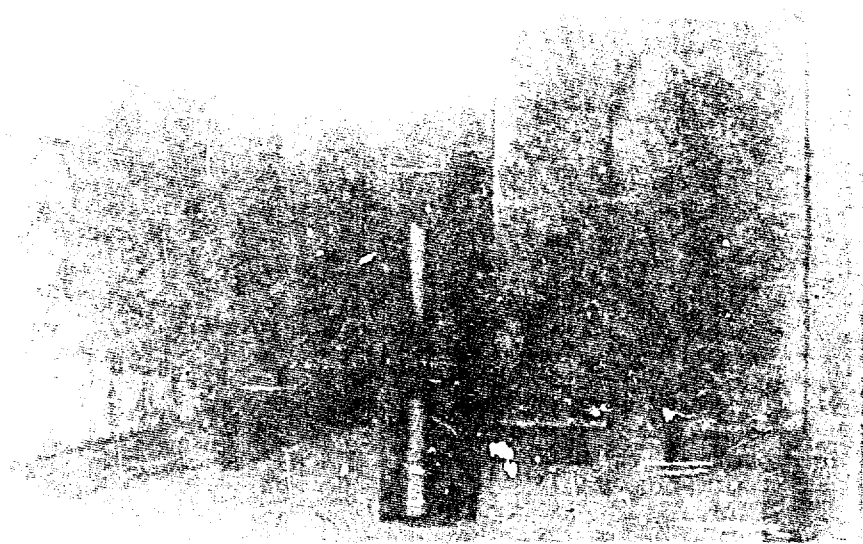
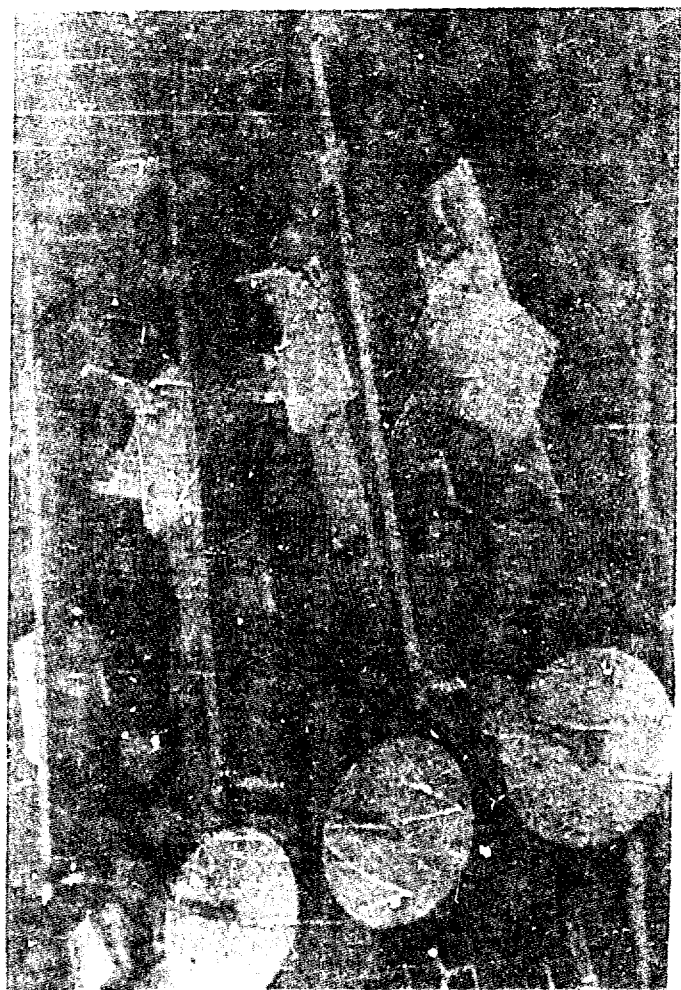
Fig. 3 - Stress-Corrosion Test Unit and Detail of Specimen Loading Arrangement.

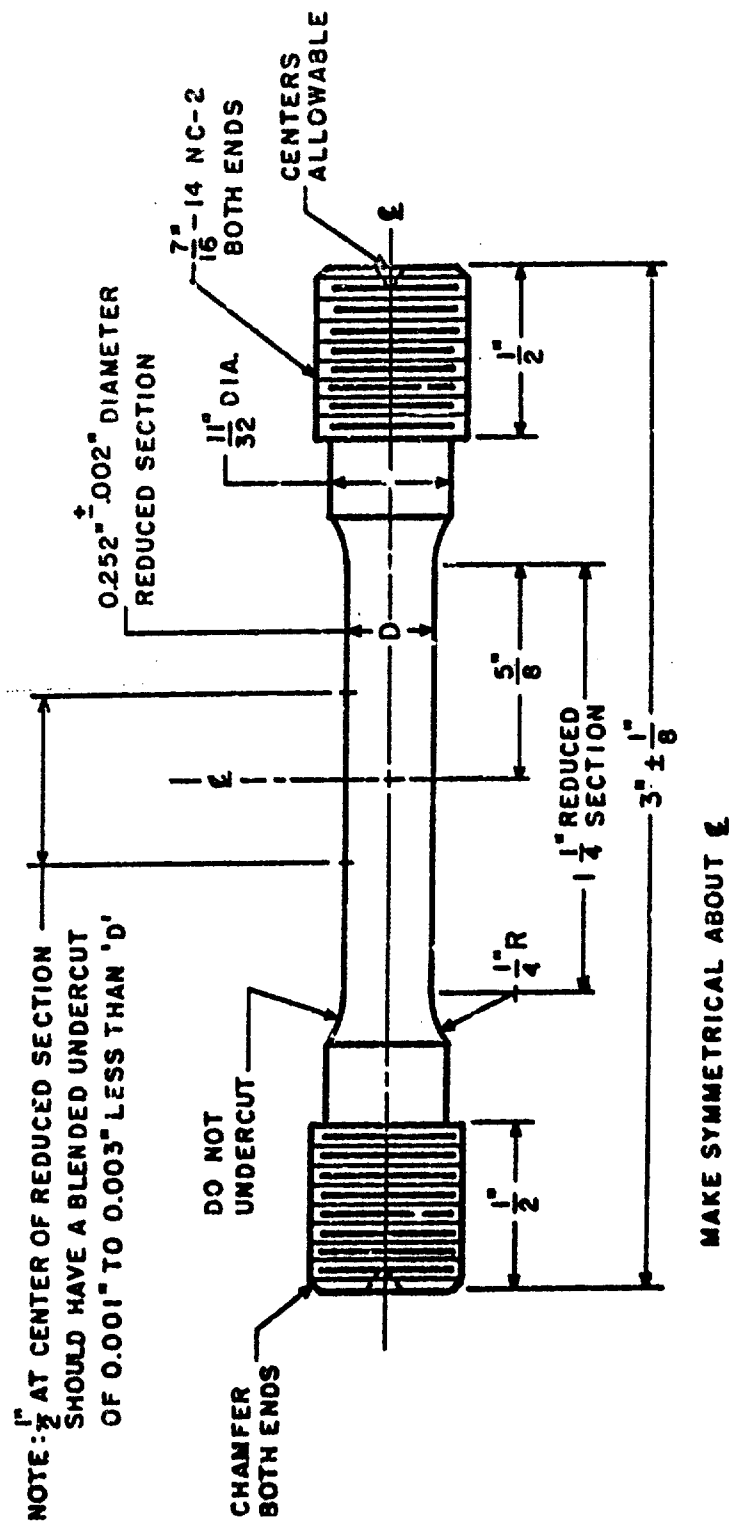
FIG. 4 - TENSILE TEST SPECIMEN FOR 7075-T6 MATERIALS.

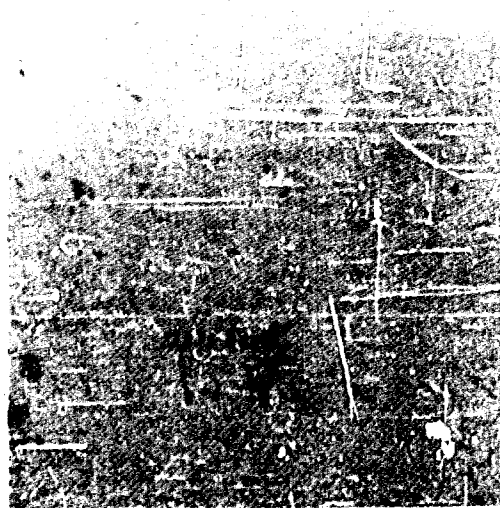
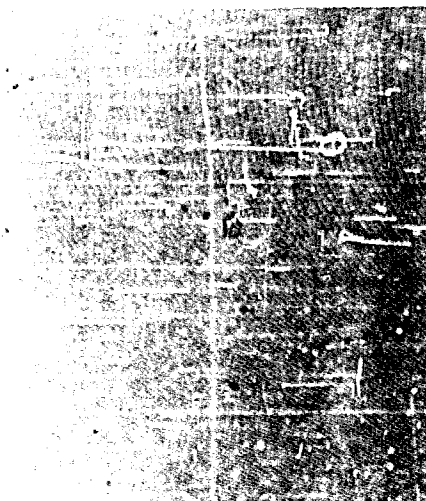
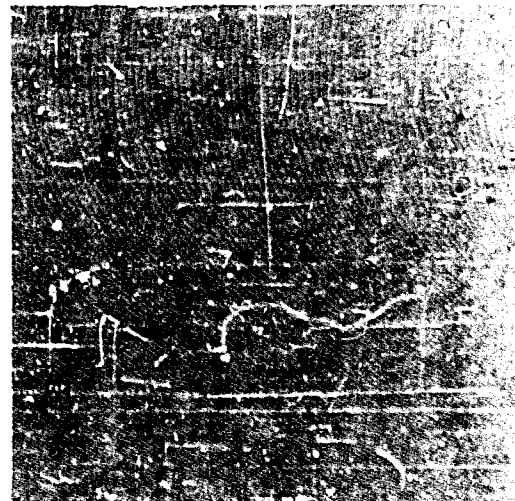
(a) Plane parallel to the rolling plane.

(b) Plane perpendicular to the long transverse direction.

(c) Plane perpendicular to the rolling direction.

Fig. 11 - Microstructures showing distribution of second-phase particles in 7075-T6 high-purity plate 1-inch thick, coarse grain size. Etchant: 1% conc. HF in water.

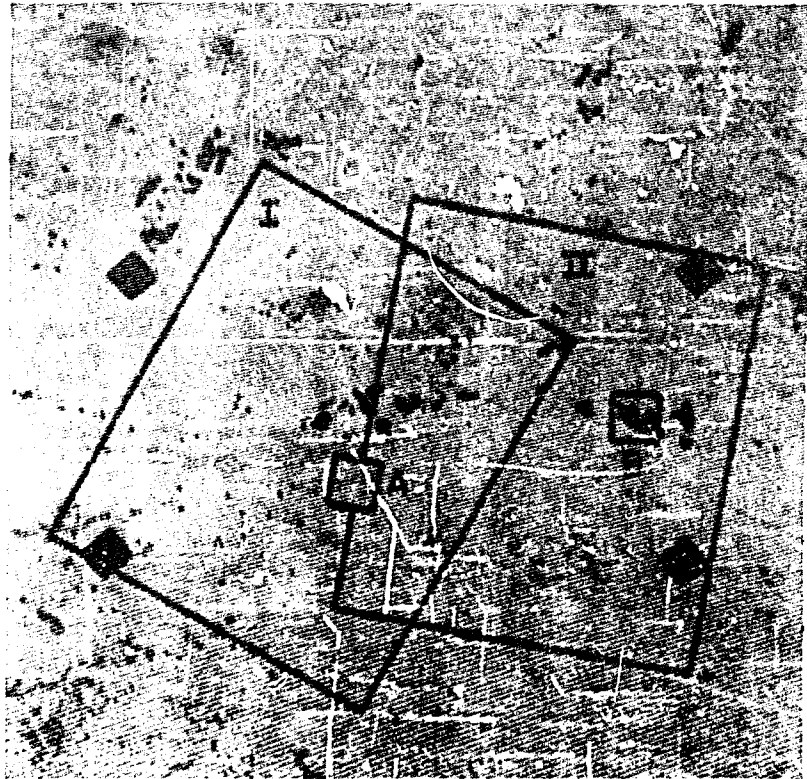
Fig. 14 - Areas on plane parallel to the rolling plane examined with the microprobe analyzer. Commercial 7075-T6 plate 1-inch thick. Unetched. The gray particles are tentatively identified as  $\text{CuAl}_2$ .

In the photomicrograph, region I is observed to contain large quantities of gray particles and a patch of two-phase particles which are black and gray. The electron image of this region is shown in Fig. 13. (The microprobe images are mirror images of the photomicrograph in Fig. 14.) Relative to the matrix, intensity differences in the electron image derive from two sources: (1) differences in surface elevation which cause shadows or intensified reflection, for example, note the microhardness impressions in Fig. 18; and (2) differences in average atomic number of phases present. In the case of the latter, second phase particles having higher average atomic number than the matrix produce light areas (relative to the matrix) in the electron image; and particles which have lower average atomic number than the matrix produce dark areas in the electron image. The electron image indicates that the phase which appears to be black is actually depressed below the surface, suggesting that it was attacked during polishing operations.

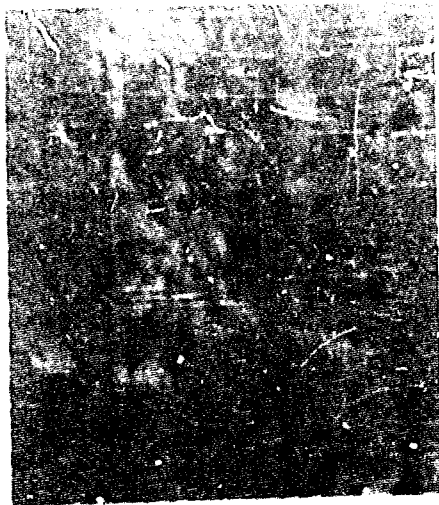
Fig. 15

Electron image of region I. Bright areas represent higher average atomic number than that of the matrix.

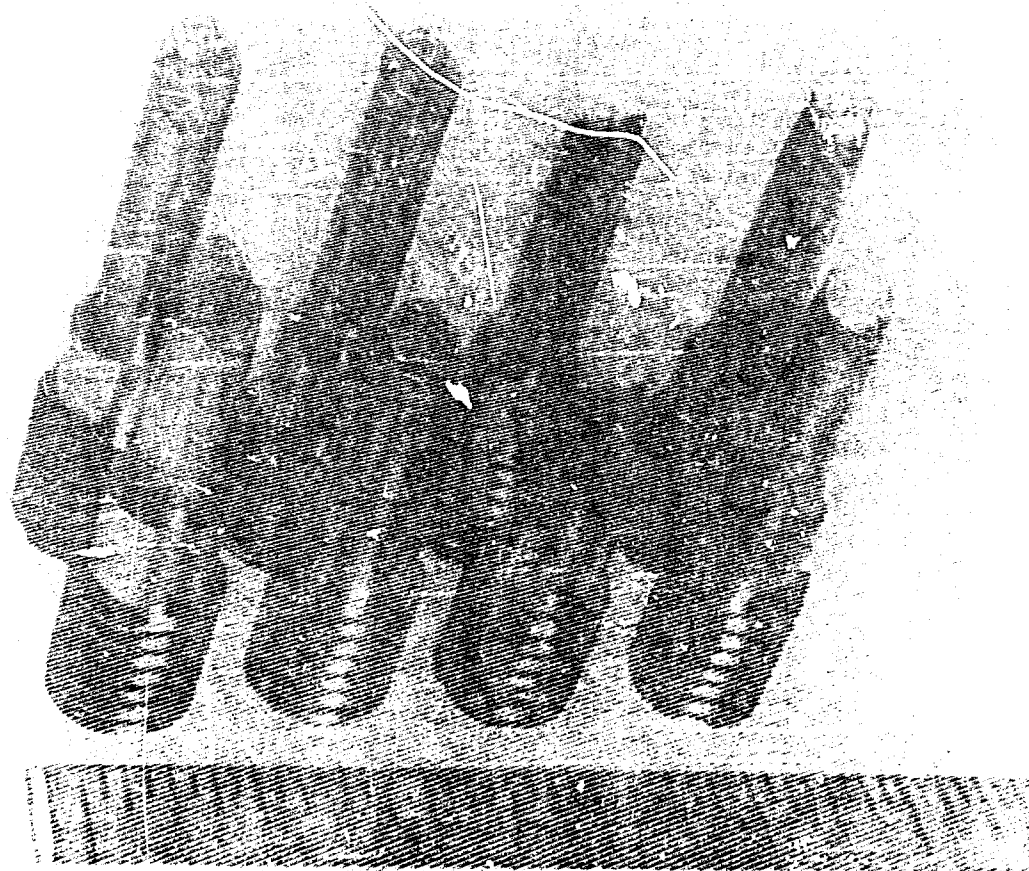
Fig. 20 - One end of each of the fractured tensile test specimens of 7075-T6 materials. From left to right: (1) commercial; (2) commercial, grain refined; (3) high-purity, coarse grain size; and (4) high-purity, fine grain size.

Results of tensile tests of longitudinal specimens taken from the 7075 materials are summarized in Table 2. The tensile properties of the two commercial purity materials are in fair agreement. The strength properties, except fracture strength, of the two high-purity materials were in close agreement; and the yield strengths were about 20,000 psi below those of the commercial materials. The fractured specimens are shown in Fig. 20. One segment of each of the specimens is shown. Note particularly the character of the fracture of the high-purity, coarse grain size material. Much of the fracture surface of these specimens consists of parallel planes all being parallel to the rolling direction and, consequently, parallel to the stress axis of the test specimens. Much of surface area of these parallel planes was covered by a thin, dark film which can be discerned in Fig. 20. This film has not been identified as yet. The specimens of commercial material showed a tendency to fracture in a similar manner; however, the steps were much smaller and there was no sign of a film under magnifications up to 30X.

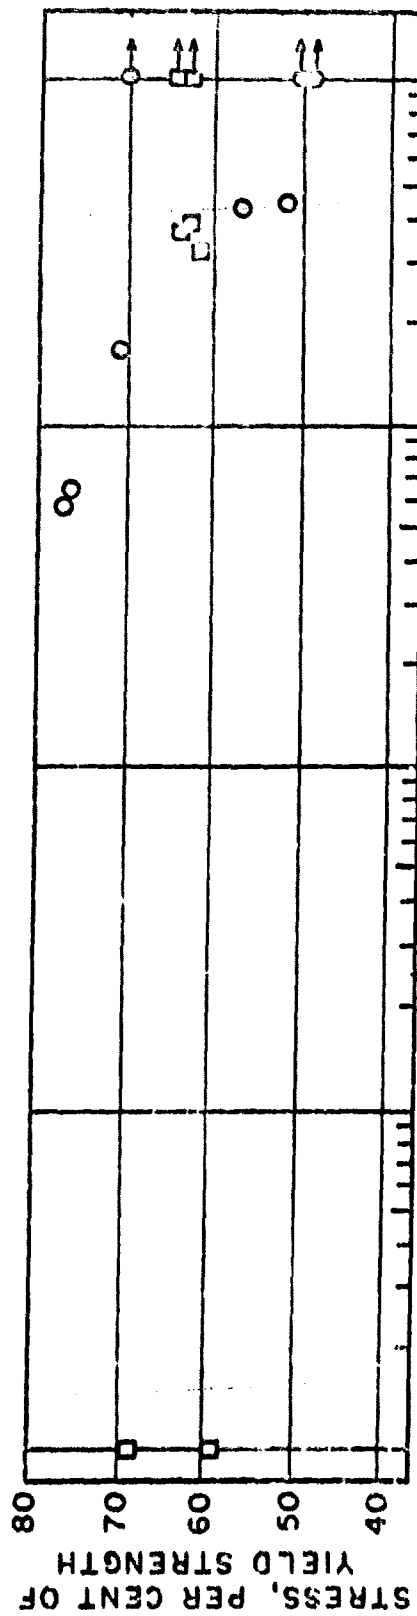
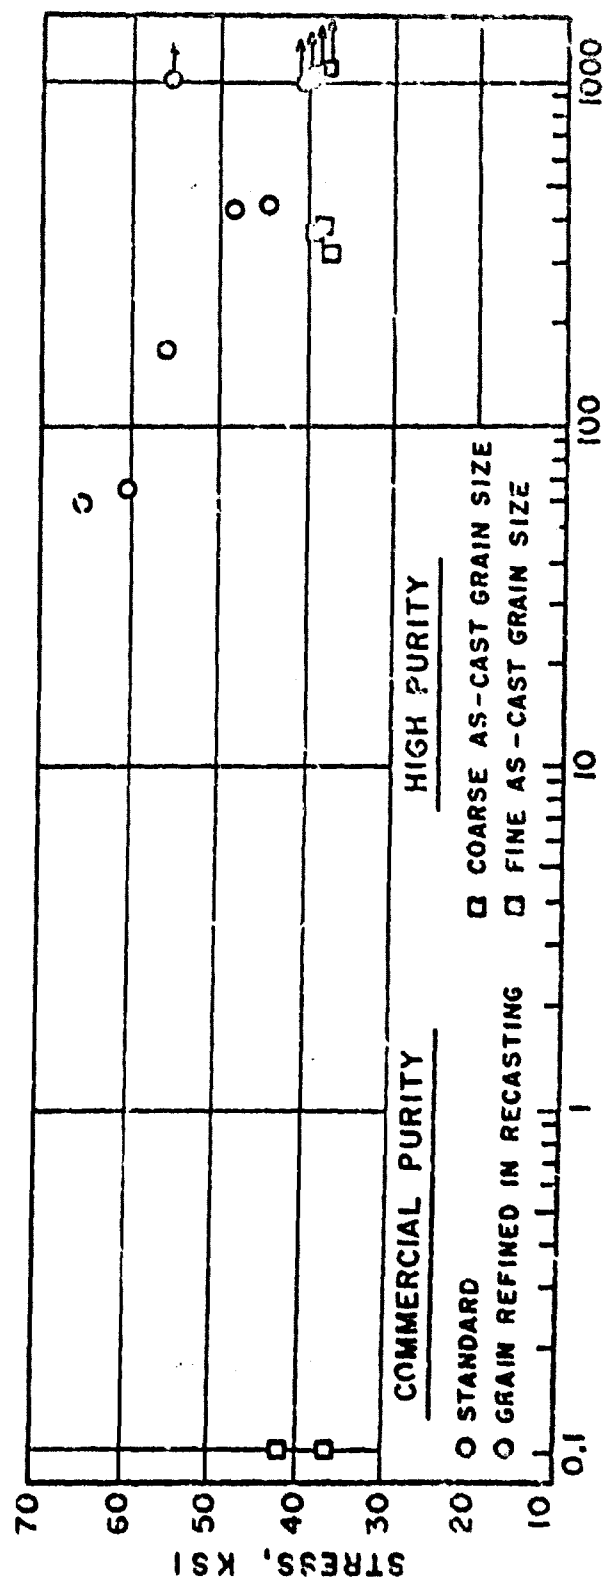
FIG. 21 - STRESS CORROSION RESULTS FOR 7075-T6 MATERIALS IMMERSSED IN DAILY CHANGED BATH OF NaCl-H<sub>2</sub>O<sub>2</sub>-AEROSOL SOLUTION.

The results of stress corrosion tests on the 7075-T6 materials are given in Tables 4, 5, and 6; Table 6 summarizes results for tests in NaCl-H<sub>2</sub>O<sub>2</sub>-Aerosol solution. These data, as shown in Fig. 21, indicate that the commercial material and the high-purity, fine grain size material behave similarly. Only specimens of commercial, grain-refined and high-purity, coarse grain size survived for more than 1000 hours. However, two specimens of the latter material failed immediately. (Specimens which failed immediately are plotted at 0.1 hour.) Since the load was first applied to the specimen and then the corrosion medium was added, such failures were not due solely to loading, and by all indications were truly the result of stress corrosion. A total of eleven specimens of the high-purity, coarse grain size material were tested in three solutions. Of these, five failed immediately. This was the only material to fail in times of less than 0.1 hour.

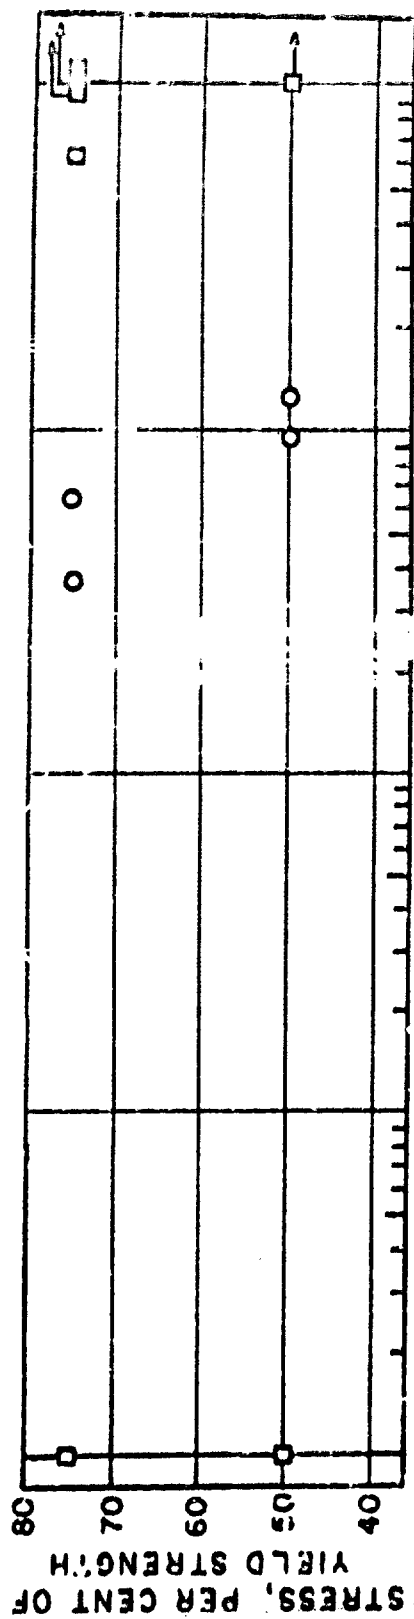
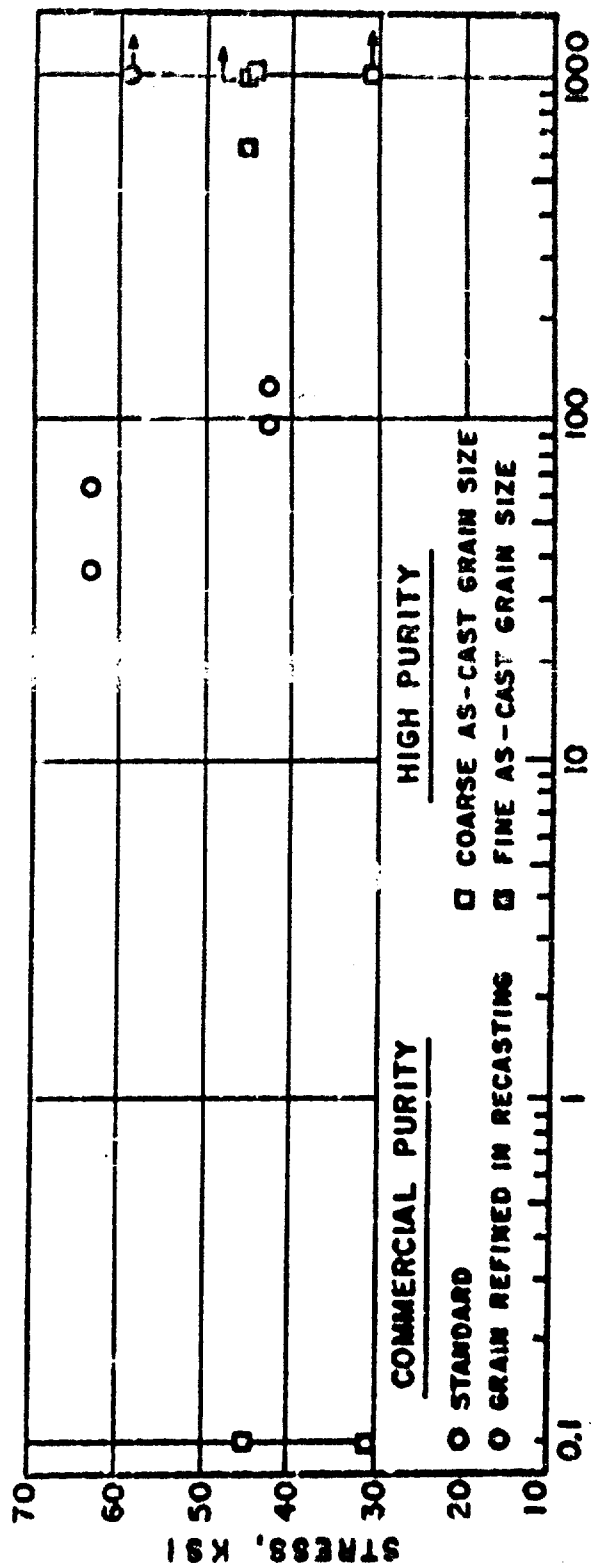
FIG. 22 - STRESS CORROSION RESULTS FOR 7075-T6 MATERIALS IMMERSSED IN DAILY CHANGED BATH OF  $\text{NaCl-H}_2\text{O}_2$  SOLUTION.

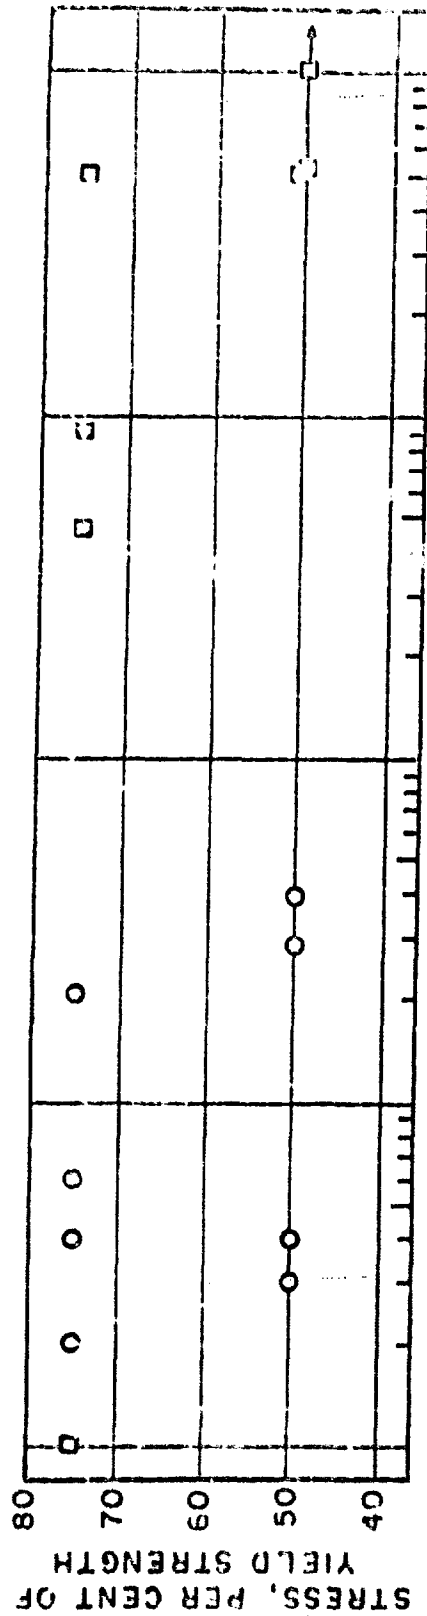
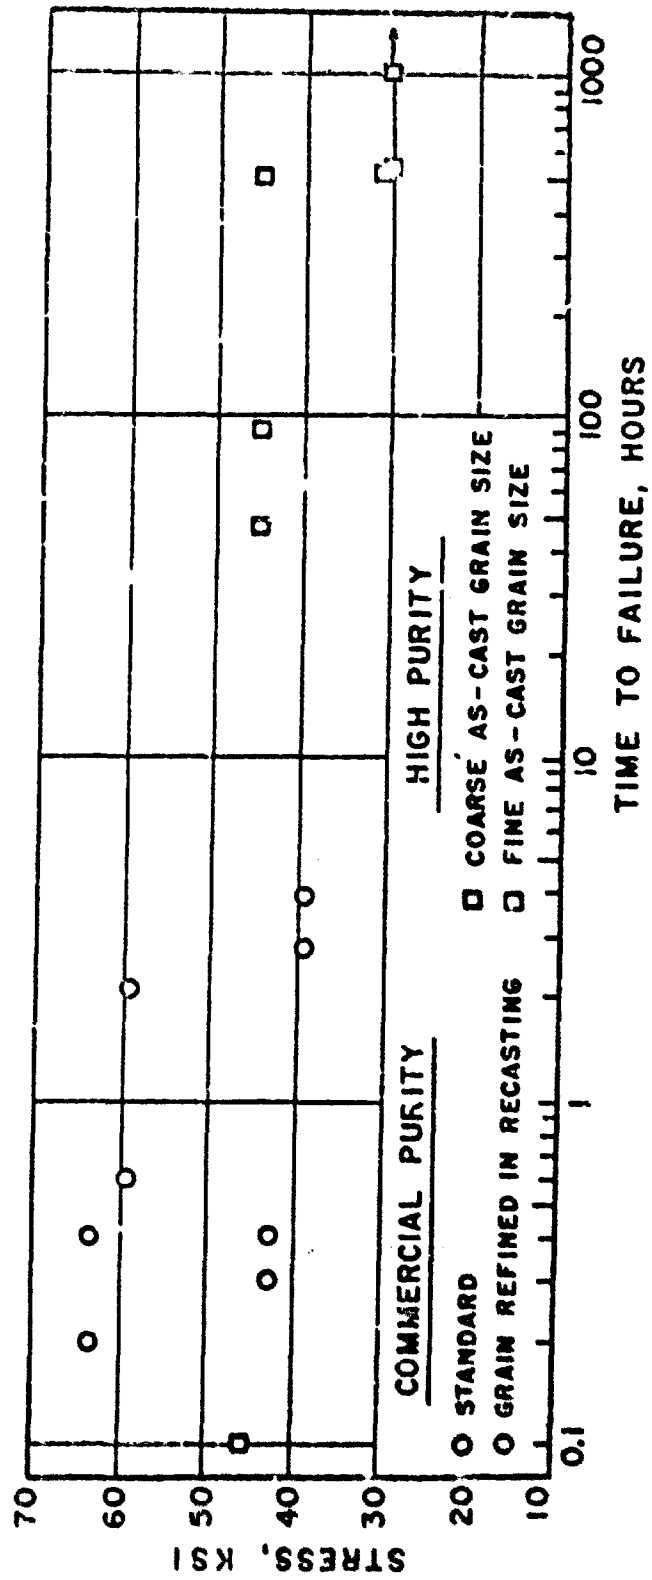
FIG. 23 - STRESS CORROSION RESULTS FOR 7075-T6 MATERIALS IMMersed IN DAILY CHANGED BATH OF  $\text{CrO}_3$  SOLUTION.

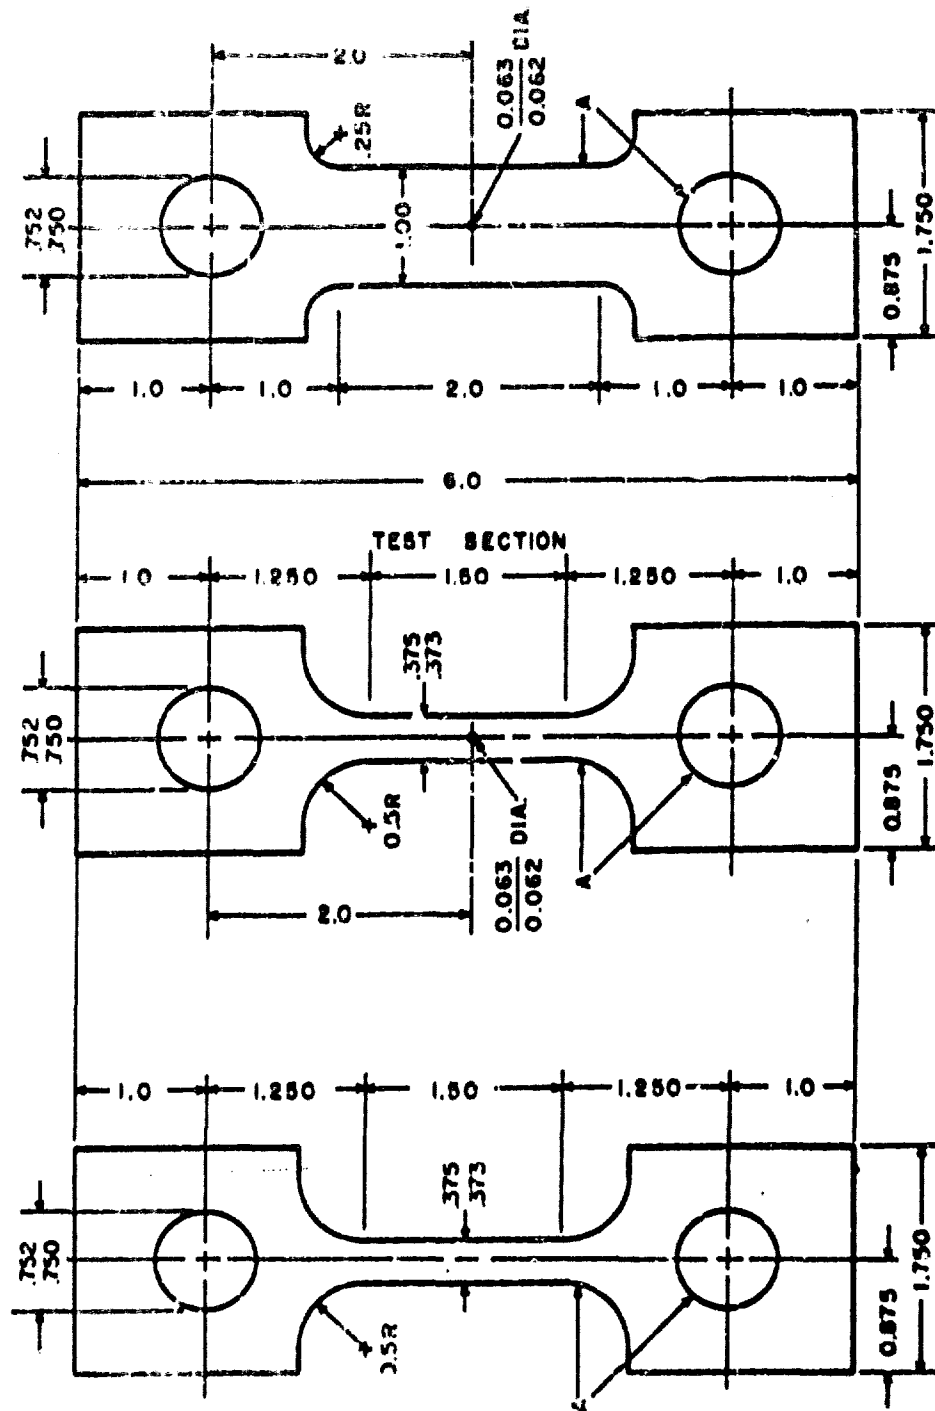
A - SURFACES TRUE TO CENTERLINE WITHIN 0.001 IN.  
 FIG. 24 - SMOOTH (LEFT) AND NOTCHED (CENTER AND RIGHT) SHEET TENSION TEST SPECIMENS.

Test specimens were of the geometry shown in Fig. 24. All specimens were transverse, since specimens of this orientation appear to be less resistant to factors which cause failure than longitudinal specimens. For testing in the presence of a notch a 1/16 in. hole was made in the center of the specimens. Such configurations represented theoretical stress concentrations,  $K_t$ , of 2.8 and 2.9 for the 3/8 and 1 in. width specimens, respectively. For stress-corrosion testing this hole was filled with a paste obtained by concentrating sea water by evaporation. In order to prevent the salt from getting on the face of the specimen, the area surrounding the hole on either side was coated with Boothguard "S" (Guard Coating Corp.) strippable lacquer. The specimen was placed on a hot plate and the salt paste was put into the hole. After evaporation of the salt paste to dryness the lacquer coating was readily stripped off.

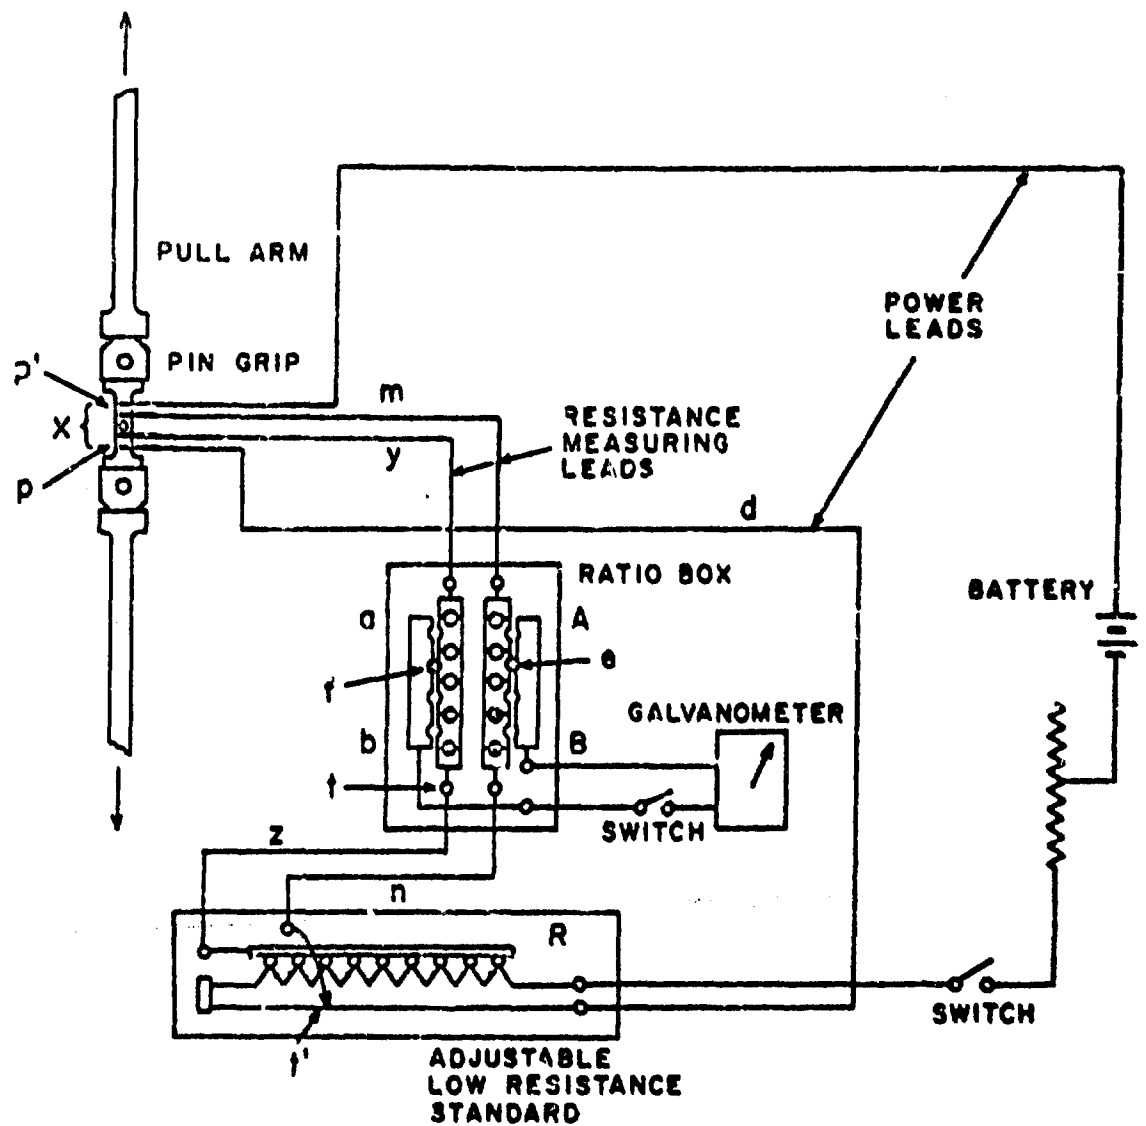
FIG. 25 - SCHEMATIC DIAGRAM OF APPARATUS FOR PRECISION MEASUREMENT OF RESISTANCE.

Crack growth propagation was indicated by measuring resistance over a gage length by means of a precision Kelvin bridge. The test apparatus is shown schematically in Fig. 25. For the Ti-8Al-1Mo-1V alloy, potential leads across the gage section were 0.018 x 1/8 in. strips of the same material spot-welded to the specimen with approximately 1/8 in. between the

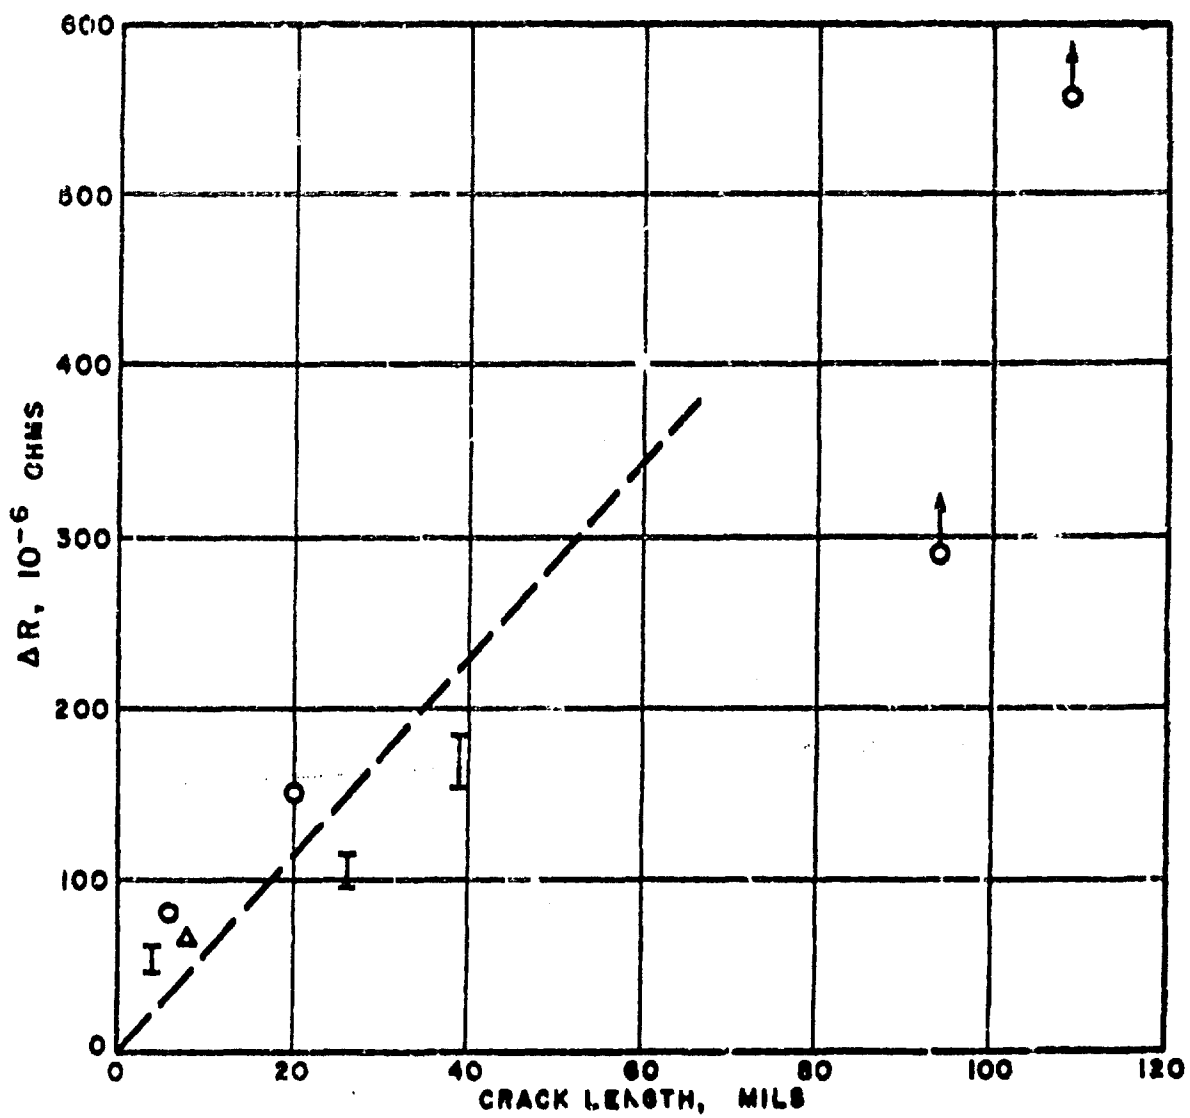
FIG. 26 - CHANGE IN RESISTANCE WITH CRACK LENGTH FOR Ti-8Al-1V SPECIMENS.

In order to determine the relation between crack length and change in resistance, center hole specimens of 3/8 in. width of Ti-8Al-1Mo-1V were used. A one mil wide notch on one side of the hole was cut by abrading with one mil diameter tungsten wire coated with a paste consisting of alumina and Johnson's cutting wax thinned with automotive transmission oil. The notches were cut approximately 8 mils deep. Crack extension was obtained by tension-tension fatigue loading. The data obtained are given in Fig. 26. Each of the vertical bars represents a single specimen. After running the crack, the specimens were heated to 1000°F for 1 hour in air, to discolor the crack face. The specimens were then pulled to fracture and the average crack length determined. The data represented by circles were determined on a single specimen which remained in the machine under load while the crack length was measured by means of microscopic observation on the surface. The accuracy of the last two points is very questionable since the crack was propagating very rapidly. The point represented by the triangle is the average change in resistance of nine specimens before and after cutting the 8-mil deep notch by means of tungsten wire-alumina abrasion.

It was found that the measured resistance was very sensitive to bending and torsional loads on the specimens. Apparently, this was due to changes in contact resistances in the circuit. The scatter in the data in Fig. 26 is believed to be due, for the most part, to the fact that the contact resistances were not the same before and after the fatigue cracks were put in.
